Subject: SQUEAK, CHATTER OR RATTLE NOISE FROM FRONT SEAT BELT BUCKLE	Bulletin No: 08-003/09
	Last Issued: 10/23/2009

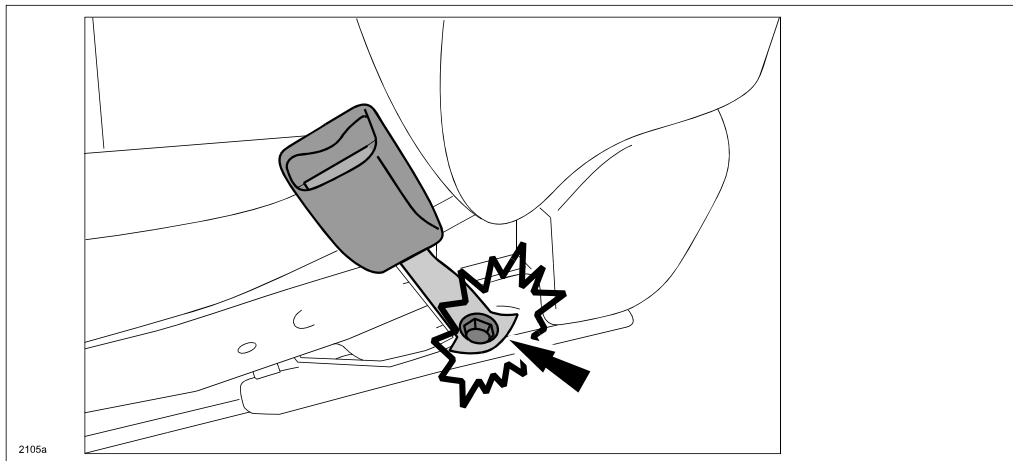
A squeak, chatter and/or rattle noise may come from the driver side seat while driving on slightly uneven road surfaces. Due to assembly variation, the bolt and washer may come in contact with each other causing the noise.

The diameter of the bolt flange has been increased during mass-production.
